Example of a Home Energy Audit

Sample Residential Energy Audit

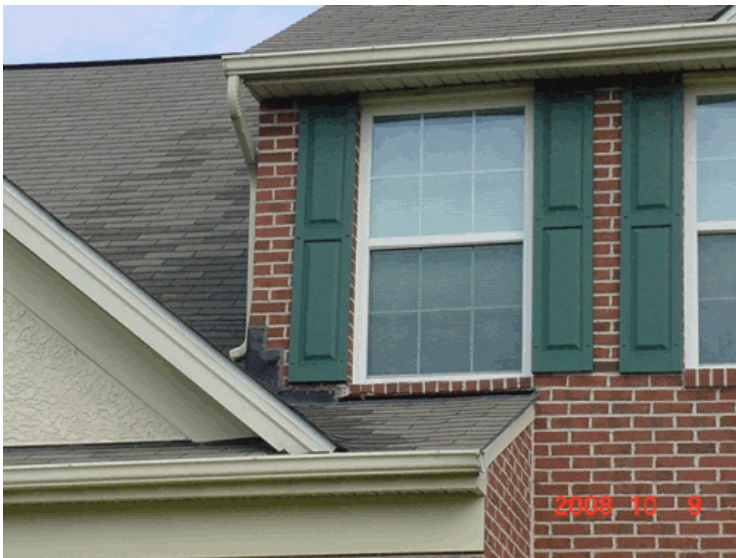
Photo 2 - The front downspout upper level should be extended around the corner. The present arrangement offers a greater potential to leak at the flashing. Also, a deflector attached to the gutter at the valley will prevent overflow during heavy rains.

10. On the exterior: add deflectors to gutters at roof valleys; extend the upper-level front downspout to direct water around the corner.
11. Seal all exterior wall penetrations, particularly at the AC lines.

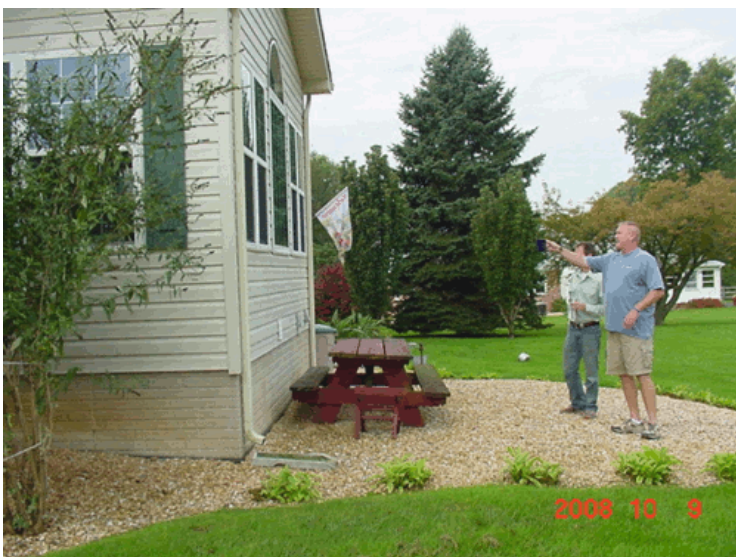
Photo 3 - Downspout discharges should be extended below grade to avoid soil saturation at the foundation.

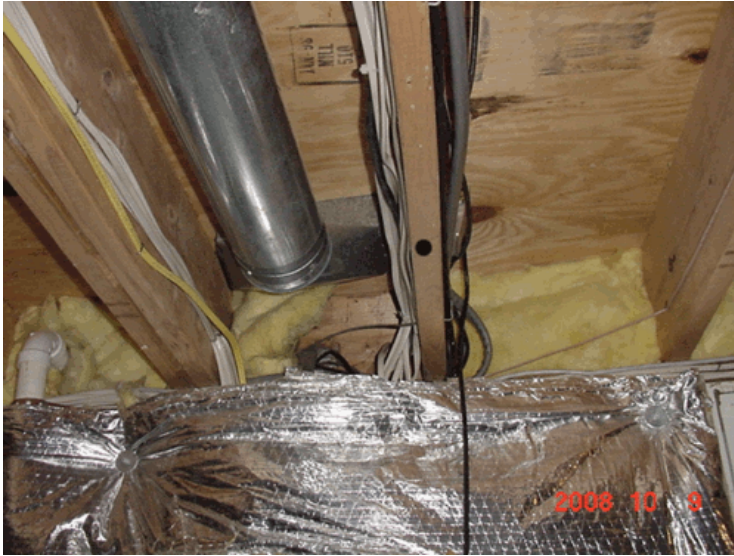
Photo 4 - All exterior penetrations should be sealed. Also, the sill plate and box plate (rim joist), should be sealed using spray foam insulation.

2. Add foam insulation at the perimeter sill plate. This seals the air leaks and reduces infiltration of unconditioned air.
3. Seal all accessible duct joints in the basement utility room and in the attic. Use mastic putty or proper duct tape.

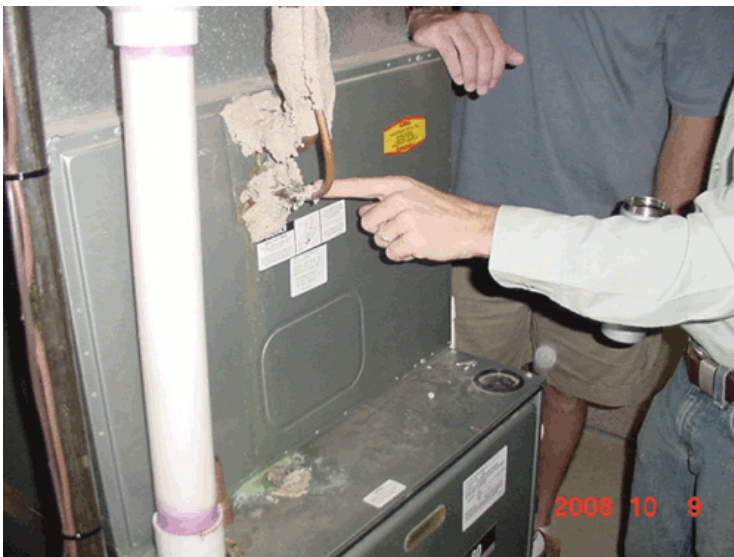
Photo 5 - The insulation used on the suction line for the AC is haphazardly installed. This should be removed and replaced with a foam insulation to match the existing black foam. Include a short piece on the liquid line at the housing.

5. Tune-up furnace and add insulation on the AC suction line at the furnace and a short (about 1"), on the liquid line at the furnace housing.
6. Seal the skylight shaft at the insulated walls using spray foam insulation.

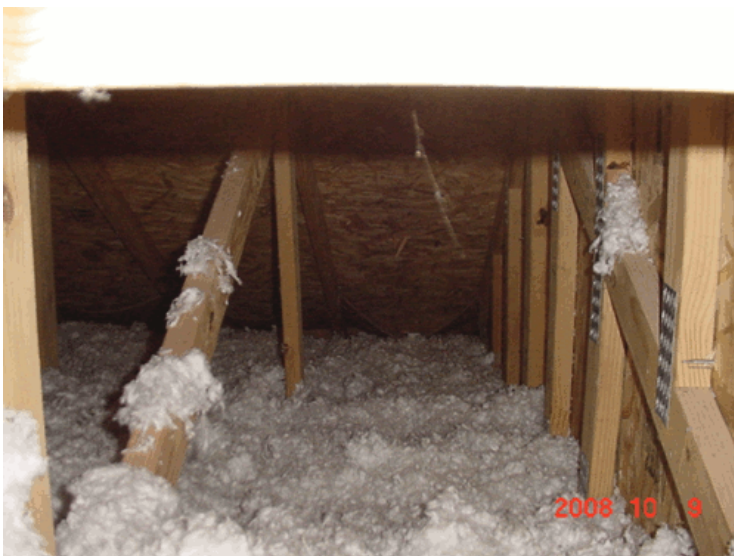
Photo 6 - Existing blown insulation is an average 10 inches thick. However, the effective R-value is estimated to about nine inches. Adding more insulation to achieve R-38 or better will exceed today's code requirements. R-50 is not unreasonable and is in line with Energy Star recommendations. It is also recommended to add rafter vents

near the soffits to avoid blocking the soffit ventilation.

7. Add attic insulation. Current ceiling insulation installed efficiency is estimated to meet an average R-9. Another 8 -10 inches of blown insulation will provide better than R-38 (recommended for this region). Consider R-50 to be consistent with Energy Star recommendations. The soffits must be prepared for adding the insulation by extending the rafter vents between each rafter by 18".

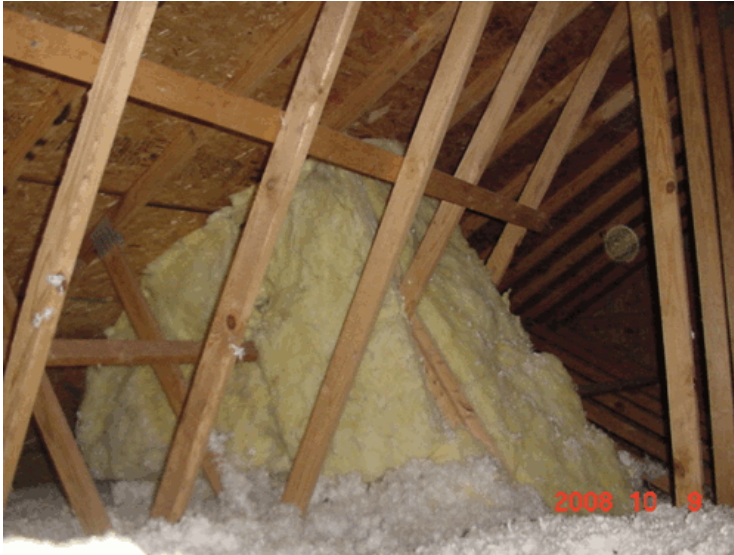
Photo 7 - The fiberglass insulation on the skylight shaft will need removal to seal the gypsum board seams using spray foam insulation. Then re-apply R-19 (6" thick fiberglass batt), 2 layers (minimum).

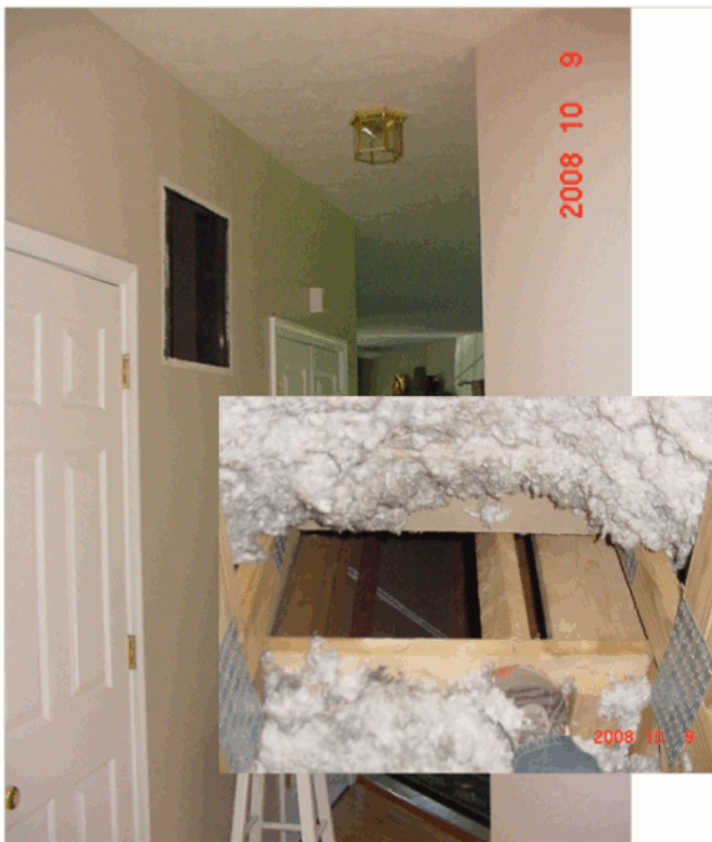
This home energy performance evaluation reveals a profound thermal envelope breach at the ceiling/attic interface in the return air wall cavity near the foyer. This condition is a gross energy waste as well as a fire stop breach. Other shortcomings typical of construction practices 11 years ago offer several energy saving opportunities as outlined in "Recommendations" of this report.

Photo 8 - With the return air grille removed, it was revealed that the attic space is totally open to the conditioned space, as can be seen in the inset photo taken from the attic looking down on the ceiling. This opening must be sealed using a plywood or gypsum cover cut to fit and sealed.

For this application, the actual value exceeds the highest calculated value by 12.6%. Obviously, there is ample opportunity to seal air leaks throughout the house. However, the most prevalent opening exists at the return air opening at the attic (see Photo 8).

1. Close off the return air shaft in the hallway. Cut to fit and fasten in place a cap (plywood or gypsum), at the top (attic), of the shaft. This will prevent the furnace fan from pulling unconditioned air from the attic. This is also a code requirement to prevent easy flame spread.

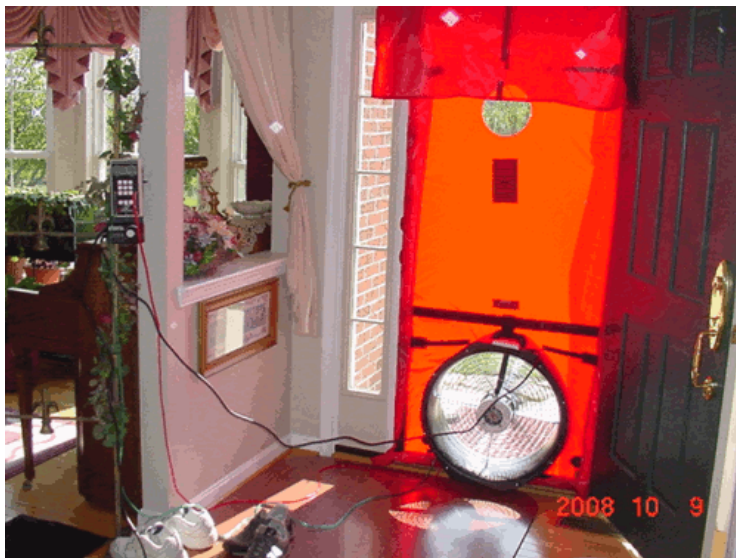
Photo 9 - Arrangement of the blower door test includes an adjustable fan with a differential pressure gauge adjusted to a specified level.
